## **MARINE INVESTIGATION REPORT**

**M99W0087**

### **BOTTOM CONTACT**

**BULK CARRIER “ALAM SELAMAT”  
FRASER RIVER, BRITISH COLUMBIA  
16 JUNE 1999**

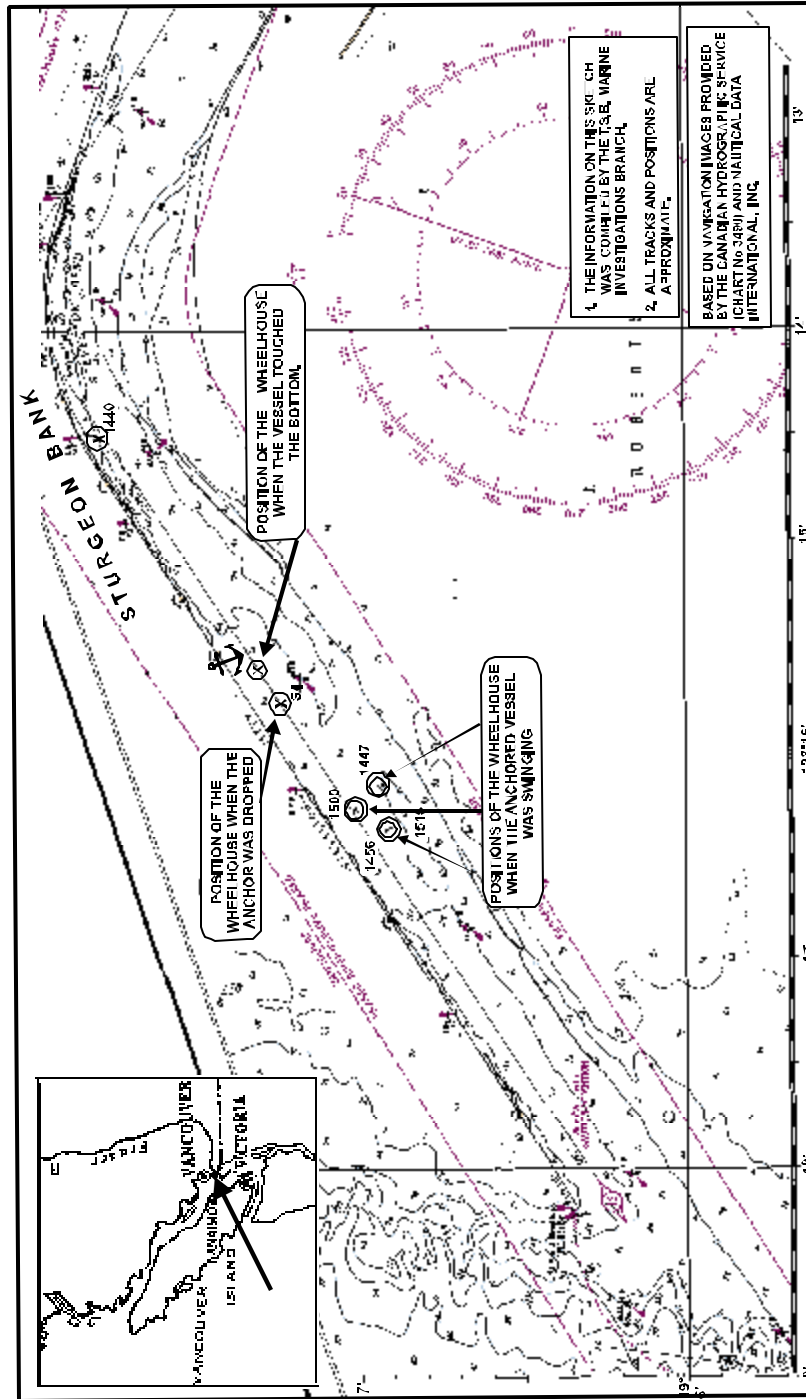
# Appendix A - Sketch of the Occurrence Area

There was no indication that the draught of the "ALAM SELAMAT" increased after leaving Fraser-Surrey docks, nor that she deviated from her track; the vessel was proceeding along the line defined by the ranges when she ran aground. As was ascertained after the occurrence, there was a shallow spot with a depth of 6.0 m (above chart datum) in the position where the vessel reportedly made contact with the bottom.

\* As per fixes plotted by the vessel's navigation personnel.

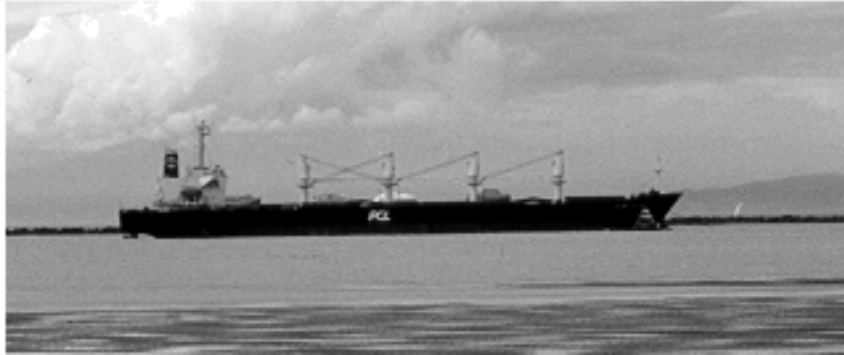
The “ALAM SELAMAT” anchored off Steveston jetty (in the background) after the grounding. Two tugs are assisting the vessel.
